# Continuous Commissioning® of a Medical Research Facility

**Energy Systems Laboratory  
Texas A&M University System**

**November 2007**

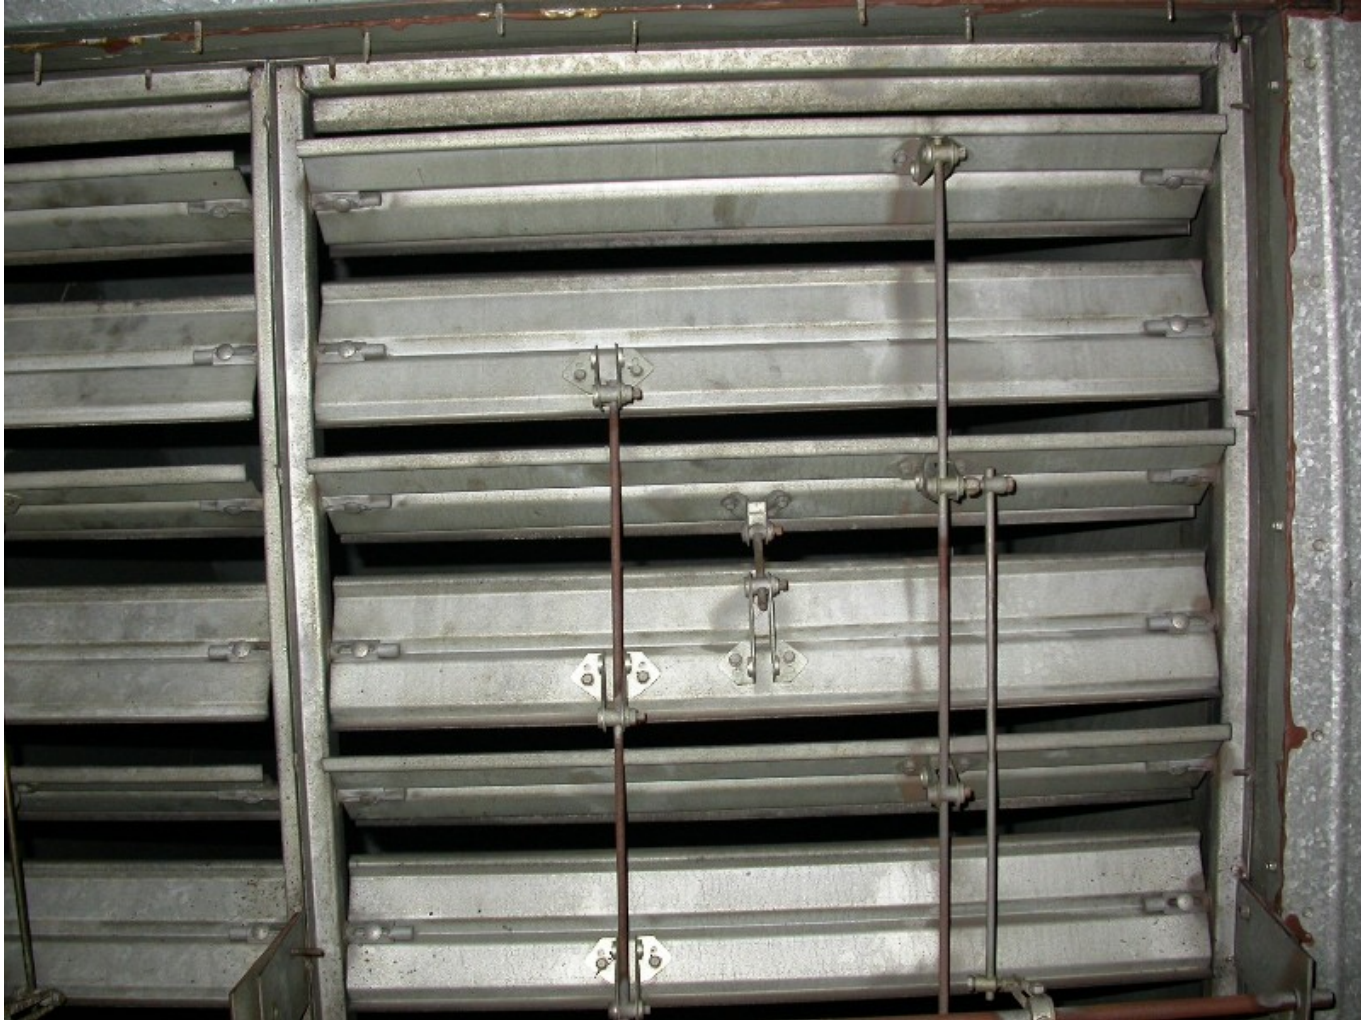
# Heat Exchanger Dampers

- Terminal box airflow readings were incorrect
- AHU-10 outside air dampers are stuck and one return air control damper is problematic
- Reheat water was a constant 105°F
- Air-to-air heat exchanger dampers not working
- Some dampers were frozen in various positions and could not move

Bypass Damper Original condition, fully open

- Heat exchanger dampers fixed open
- Bypass dampers still able to modulate
- Modified control of dampers to be based on discharge temperature
- Discharge setpoint for damper control 73°F in summer, 1°F above supply setpoint in winter
